**EVALUATION OF SSME HIGH PRESSURE  
LIQUID OXYGEN TURBOPUMP BEARINGS**

**GEORGE C. MARSHALL SPACE FLIGHT CENTER  
MARSHALL SPACE FLIGHT CENTER, ALABAMA**

**April 6, 1979**

**BATTELLE  
Columbus Laboratories  
505 King Avenue  
Columbus, Ohio 43201**

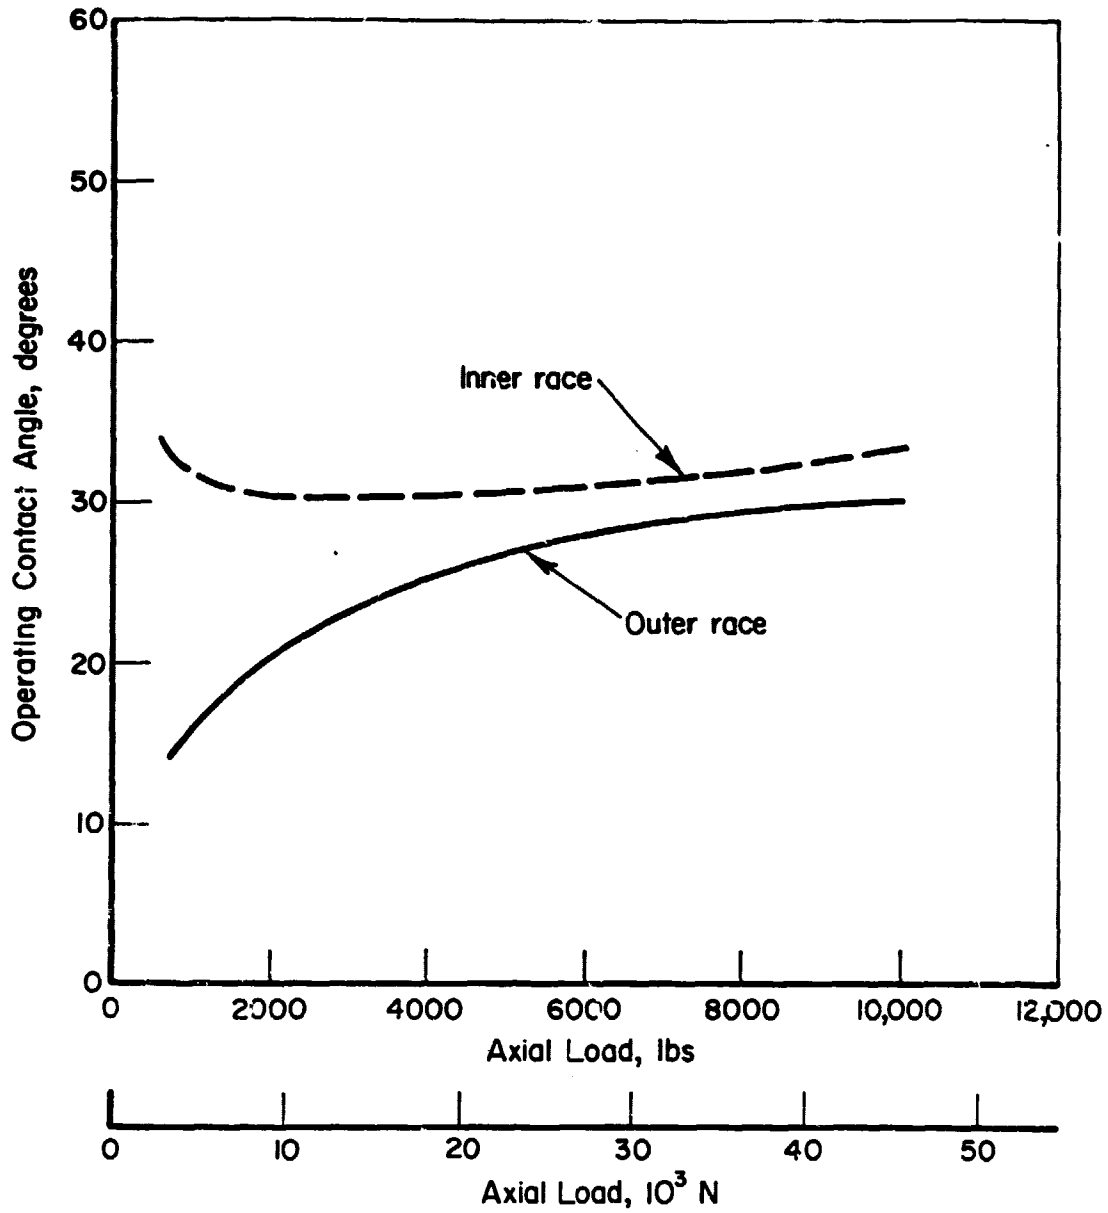
FIGURE 13. EFFECT OF AXIAL LOAD ON CONTACT ANGLE IN BEARING

The characteristics of the bearing analyzed is shown in Table 2. Figure 13 shows the effect of axial load on predicted contact angle. Note here that the outer-race contact angle is more sensitive to load than is the inner. The inner-race contact angle can be assumed to be approximately 32 degrees for all conditions analyzed.

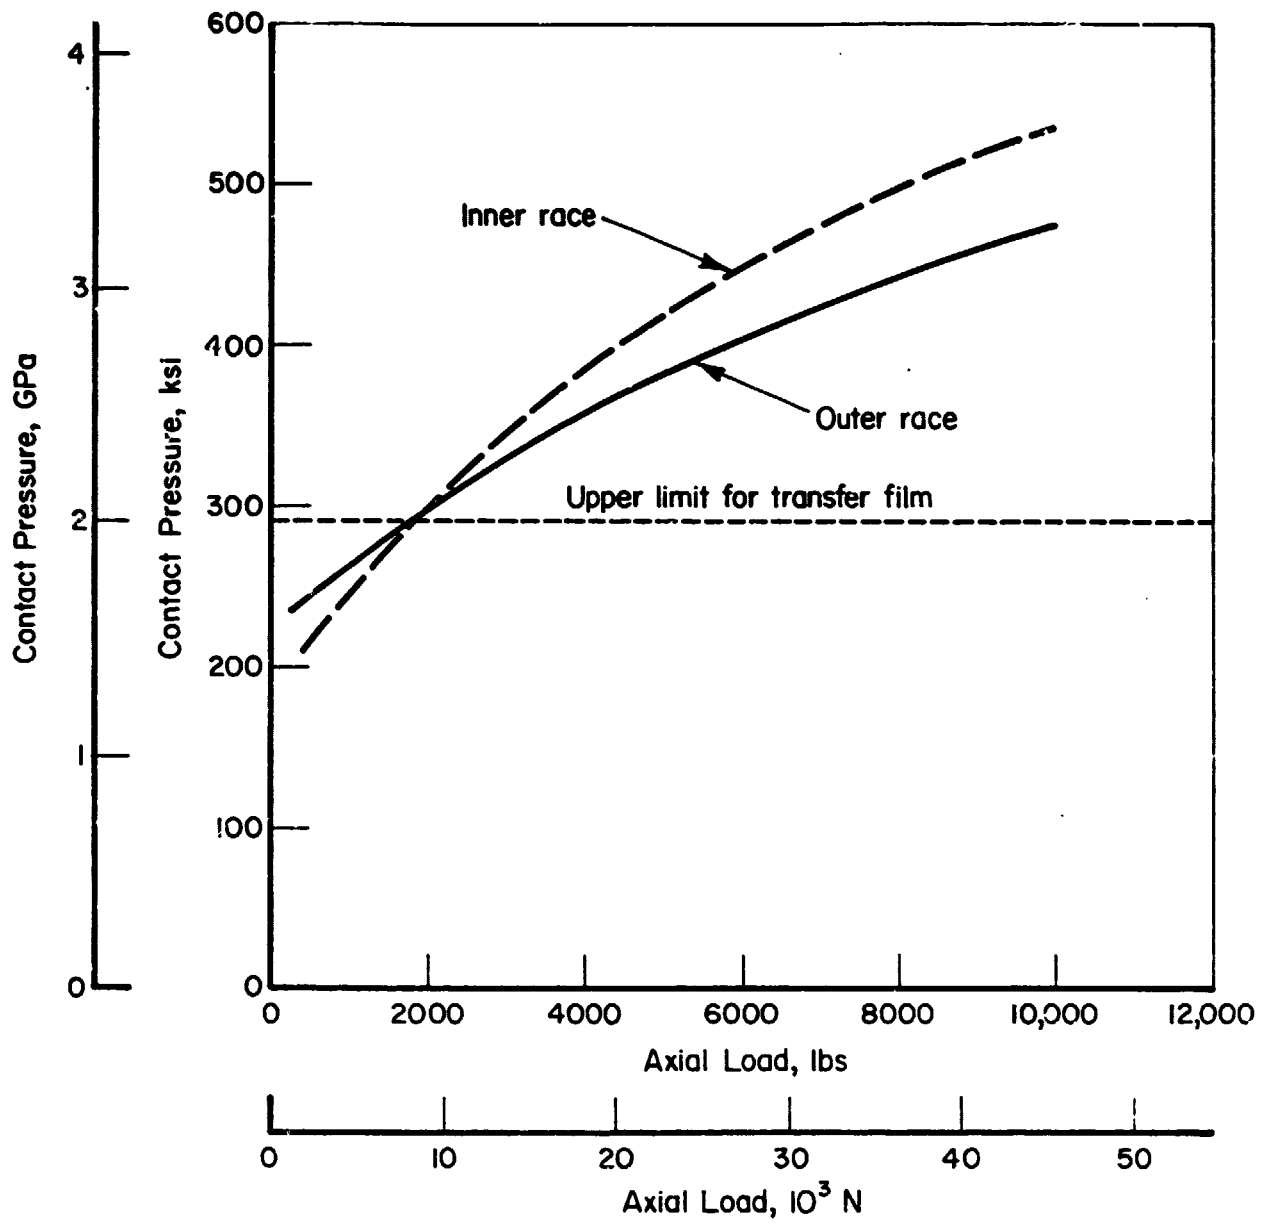
FIGURE 14. EFFECT OF AXIAL LOAD ON BEARING STRESS

Figure 14 shows the effect of axial load on contact stress. It is obvious that increasing load seriously increases contact stresses. Also shown in Figure 14 is the upper stress limit for effective transfer-film lubrication. This limit was discussed in our previous report (November 1978) and is based on some cursory experiments in another project. The accuracy of this presumed limiting condition, thus, is unknown for the shuttle configuration, although it is by no means a conservative number. Assuming that this upper limit is accurate, it is apparent that axial loads in excess of 90,000 N (2000 pounds) can be extremely detrimental to bearing performance.

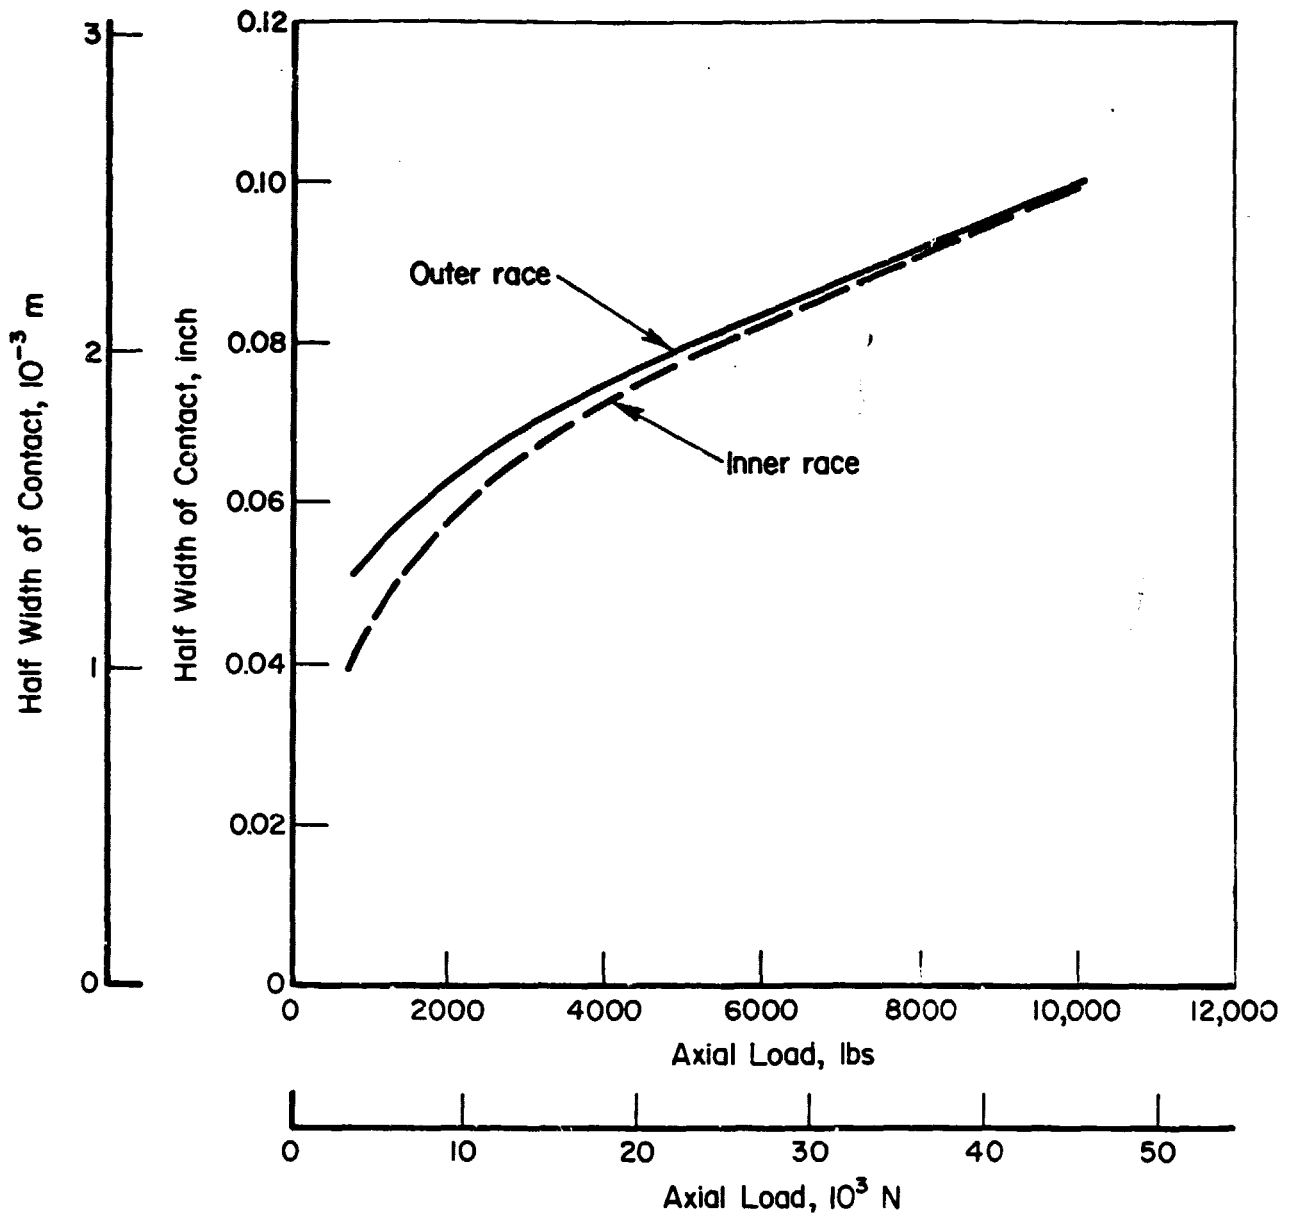
FIGURE 15. EFFECT OF AXIAL LOAD ON CONTACT WIDTH

Figure 15 shows the variation in ball track width with increasing axial load. At loads of, say, 27,000 N (6000 pounds), the total track width is 4 mm (.162 inch). As will be discussed, this is equivalent to the observed track width in bearing 8517903.

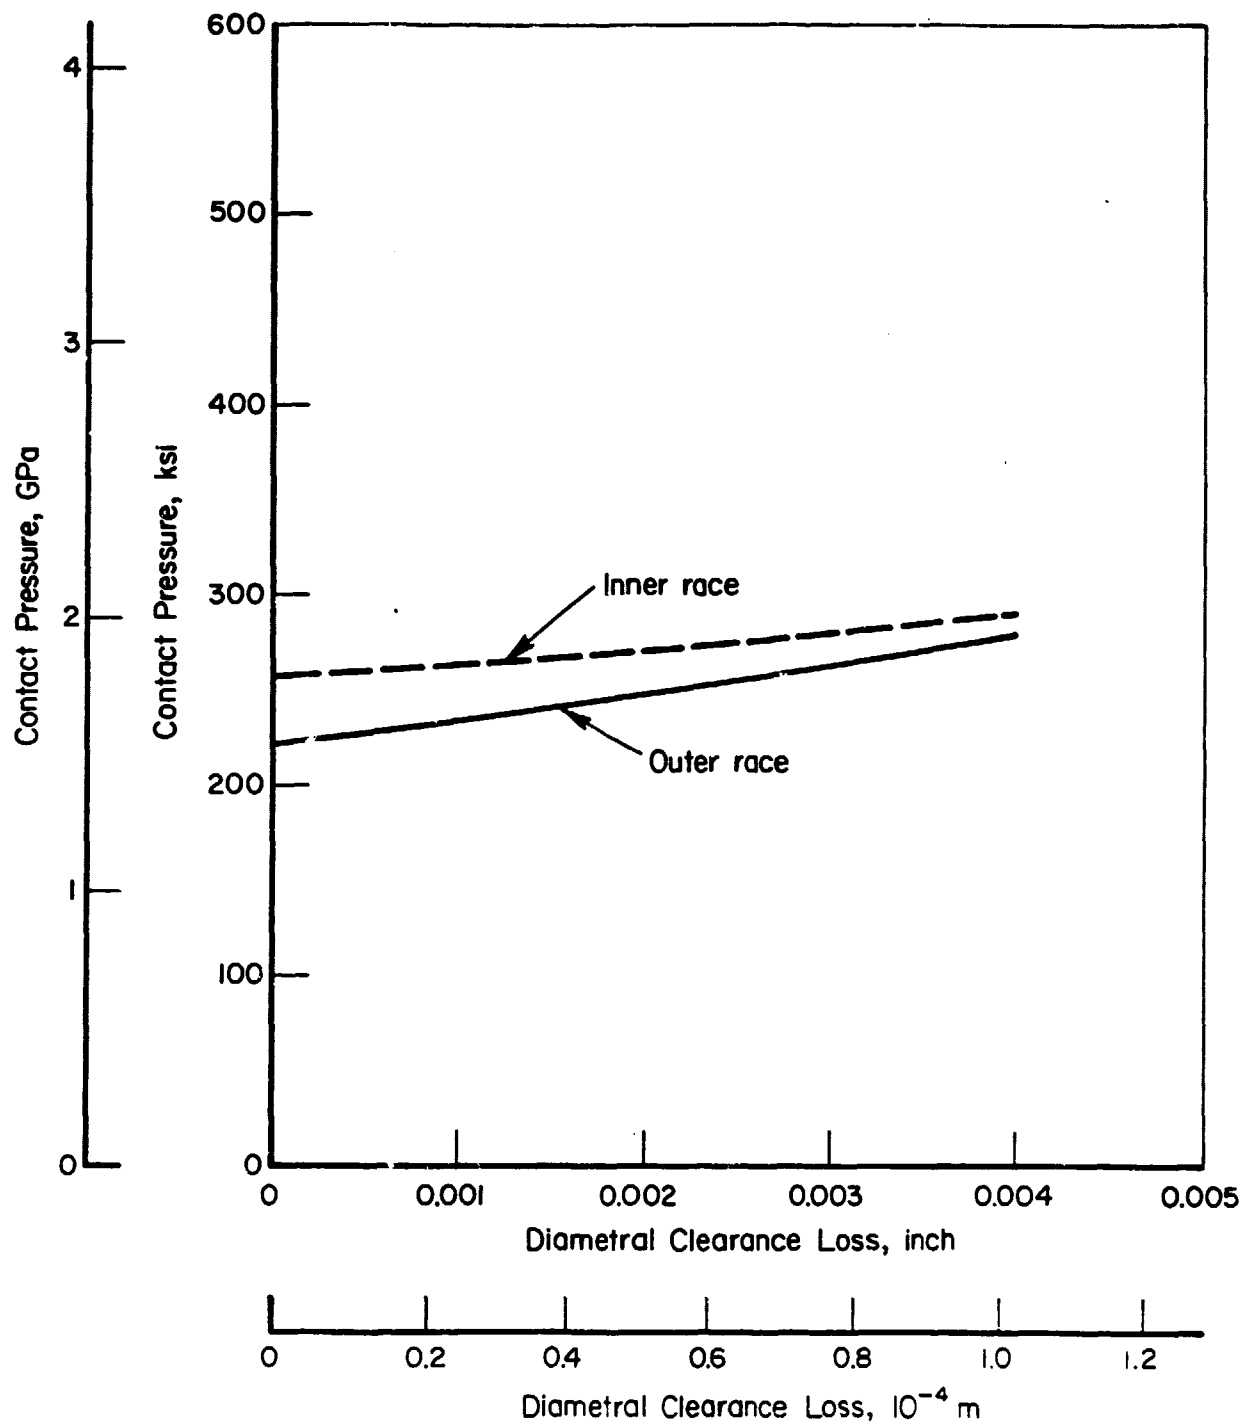
FIGURE 16. EFFECT OF LOSS OF DIAMETRAL CLEARANCE ON CONTACT STRESS - 850 POUNDS AXIAL LOAD

Figure 16 was prepared to show the effect of loss of internal clearance on bearing stresses. It can be observed that the bearing is quite tolerant of diametral clearance losses in excess of .1 mm (.004 inch). It is unlikely, then, that clearance loss due to large inner race temperatures are a major contribution to bearing distress.

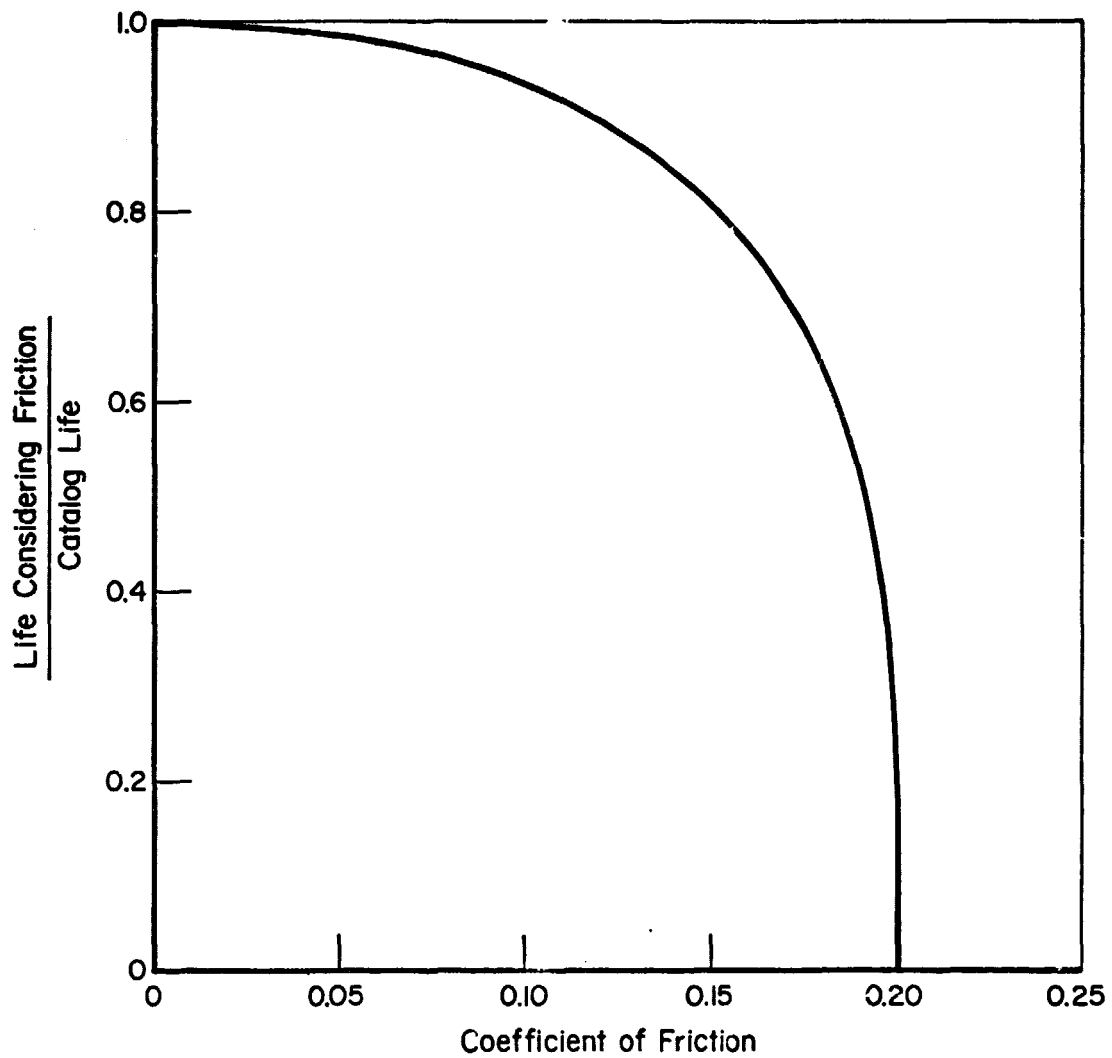
FIGURE 19. EFFECT OF FRICTION ON LIFE CALCULATIONS FOR ROLLING ELEMENT BEARING

"zero." Relative bearing life is shown as a function of coefficients of friction in Figure 19. The relationship between  $z_0$  and friction is modeled after the work of Smith and Liu\* and, realistically, is only rigorous for line contacts (plain strain) problems.

The above calculations indicate that in order to optimize bearing performance, it is mandatory that, as a minimum, adequate transfer film lubrication must be maintained. This means that the stresses in the bearing must be kept below 2 GPa (280,000 psi). With the current configuration, achieving this stress level is very difficult as shown in Figure 14. Computer runs were made for other bearing configurations involving minor changes in curvature and contact angles from the current design. The results of these runs are shown in Figure 20. It appears that reducing the curvature (both inner and outer race) from 0.53 to 0.52 could greatly enhance the probability for bearing survival. Note however, that changing the contact angle does not appear to improve the stress levels. Full bearing tests should be conducted with the bearing of 0.52 curvature to check the validity of this recommendation.
